Rural Water Supply and Sanitation Project in Western Nepal Phase II

# Tube well scheme functionality Learning outcomes of RWSSP-WN II RWSSP-WN BRIEF 11-2018

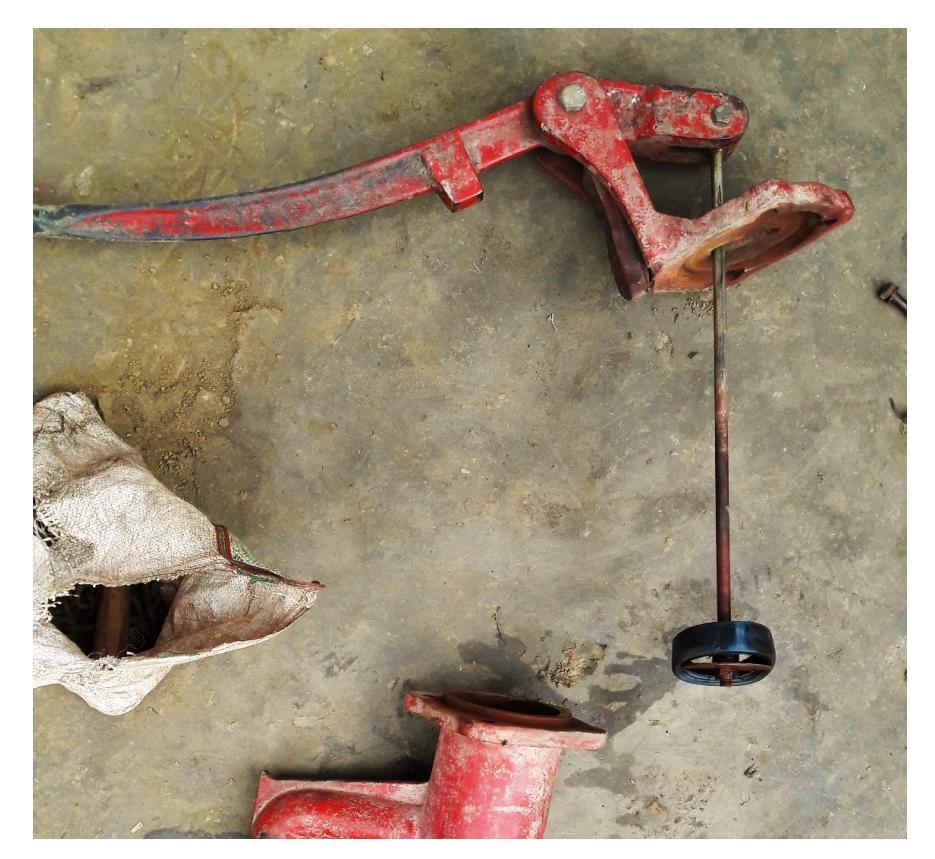
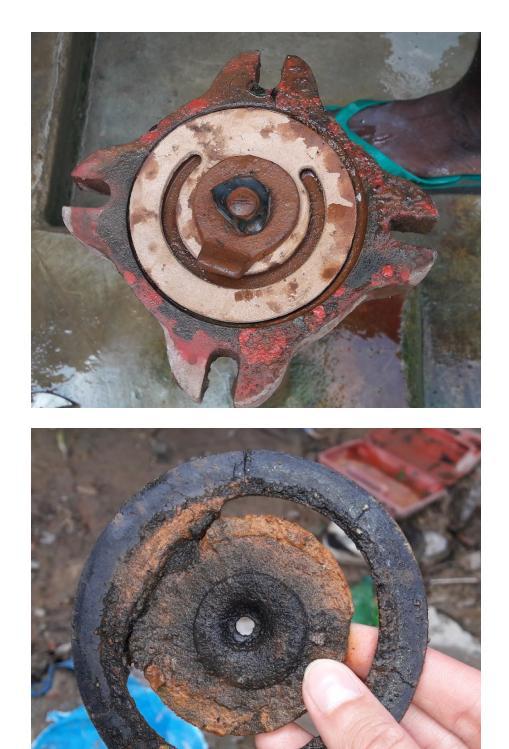
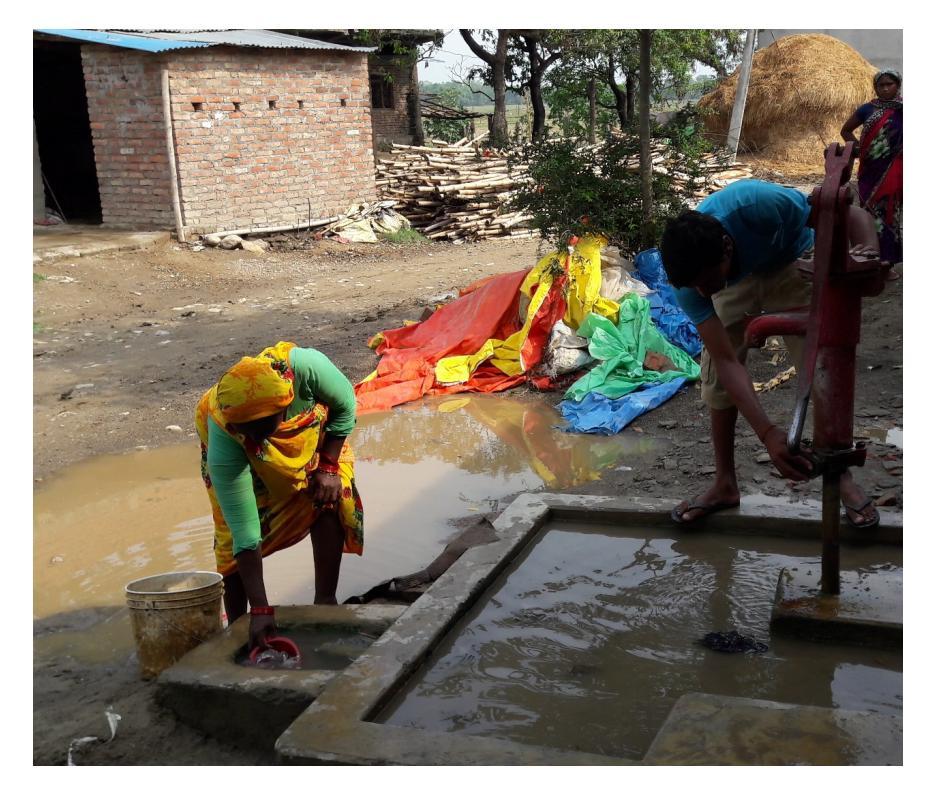
Figure 3. Left: Rubber check-valve of the piston. When the piston moves down, the valve opens and when up, the valve closes. Above right: New rubber valve that covers the base plate airtight. Below right: Worn-out rubber valve

Once tube well schemes are successfully installed, there is not much maintenance to do. Still, during our recent study in Rupandehi district, several tubewell schemes were found unfunctional due to the difficulty of lifting water. The reason was mostly found to be warn out valves. Handpump functionality is based on suction that is created when a piston moves up and down the pump cylinder. Two rubber check-valves are needed, one in the piston and one on the base plate to control water flow into the cylinder and out the spout. Check-valves are easily available in the local market. The scheme users just need to be aware of the issue and know how to change them (Figure 3).

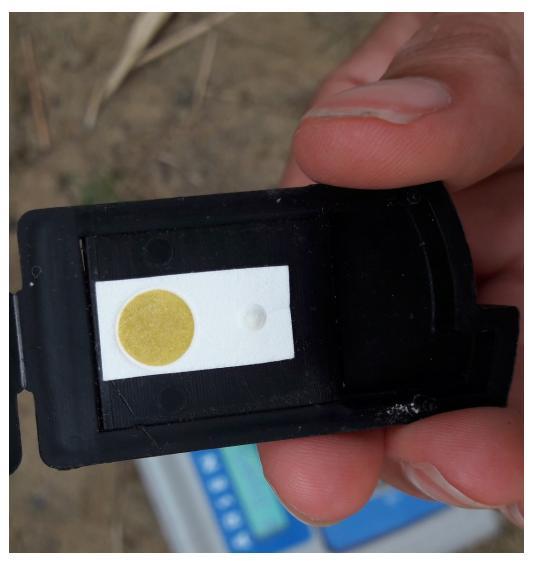
Figure 5. Yellow color indicates arsenic contamination.

Arsenic is a problem also in RWSSP-WN II supported tube well schemes. The Project tests arsenic using digital Wagtech Arsenator field kit that gives results from  $2\mu g/I$  to  $100 + \mu g/I$  (Figure 5). Based on arsenic tests conducted in Nawalparasi and Rupandehi districts in 2017 and 2018 it was found that arsenic is found both in schemes over 100 feet and under 100 feet. In total, 41 % of the 158 tested schemes exceeded the WHO arsenic standard and 16 % exceeded the Nepali standard.

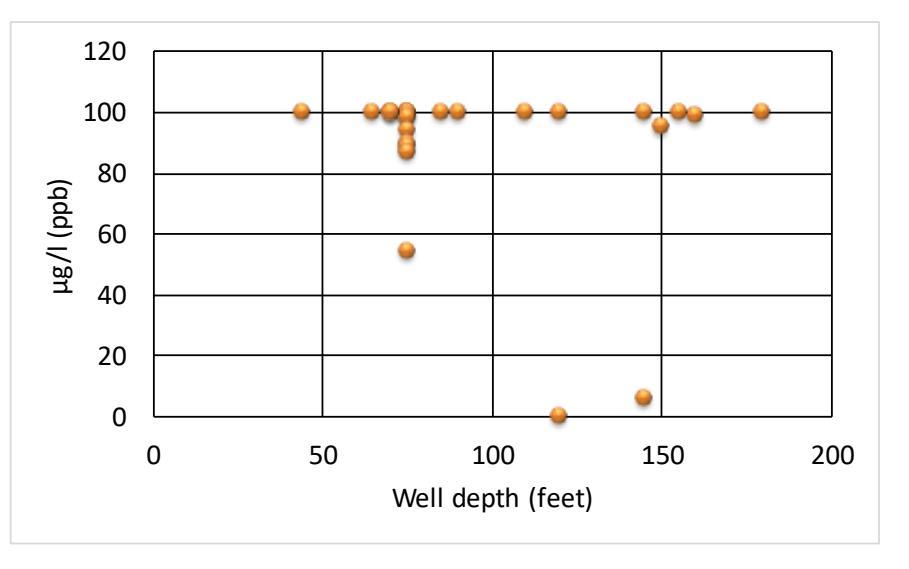
120 100 100 80 60 40 20 0 50 100 150 200 250 Well depth (feet)

Figure 6. Depth of wells with arsenic contamination  $\geq 10\mu g/I$  (N=65). The figure shows that both shallow and deep wells were

Figure 6 shows the depth of the 65 tested wells that have arsenic exceeding the WHO standard. As seen in the figure, both shallow wells and deep wells were found contaminated and also heavily contaminated (100+  $\mu$ g/l). Based on the test results, well depth seems not to guarantee water safety. In total, 35 % of the 133 over 100 feet deep wells tested were found contaminated with arsenic.

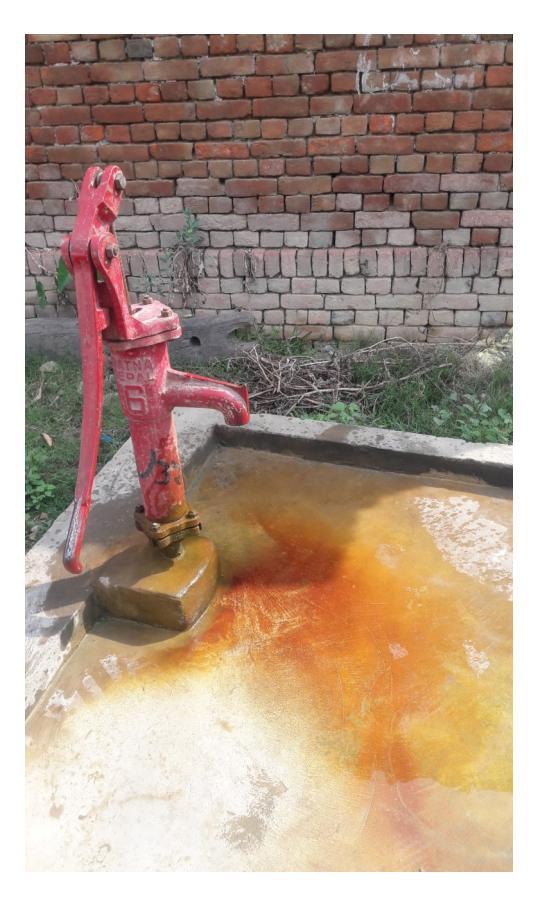
Figure 8. Iron in the groundwater has discolored the tube well platform.

Iron and manganese are some of the most abundant metals in the earth's crust<sup>8,9</sup>. The soils of Terai contain a large amount of iron oxides, which result in iron contamination in the groundwater.<sup>3</sup> Taste of iron as well as stains in laundry and hardware can be noticed with concentrations above 0.3 mg/litre<sup>7</sup> (Figure 8). As per the Nepal national drinking water standards, the limit for iron is 0.3 mg/l<sup>6</sup>. Iron also promotes bacterial growth that might result in slimy coating in the piping.<sup>8</sup>
